Replacing my Hurley 22 Ruddertube

There are already a few guides to replacing H22 ruddertubes on the Hurley Yahoo Group website. This is not much of a guide at all, but I wanted to contribute something, if only a "how not to" guide.

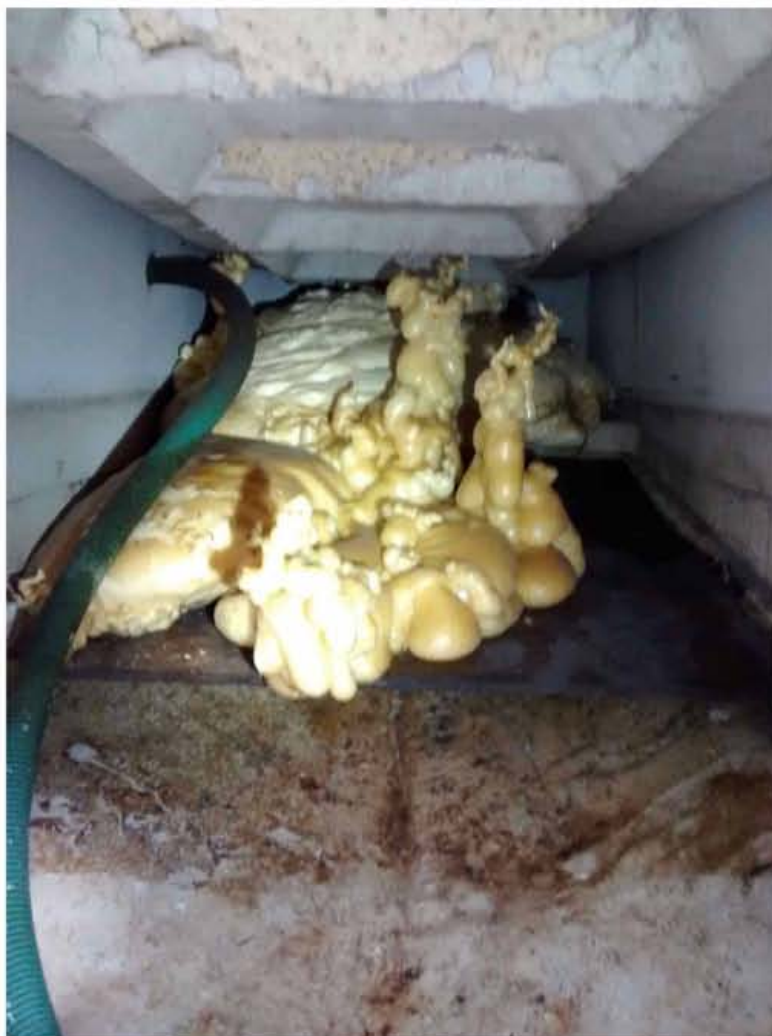
'It came from ...outer space!'

The cause of this unsightly mass of expanding foam had me perplexed, and so I enquired with the broker if they might pass on my question to the owners to offer any explanation as to why it was there. Some time later- "no idea" was the response. So I thought to myself, "oh well, here's my money!". And then I had my first boat.

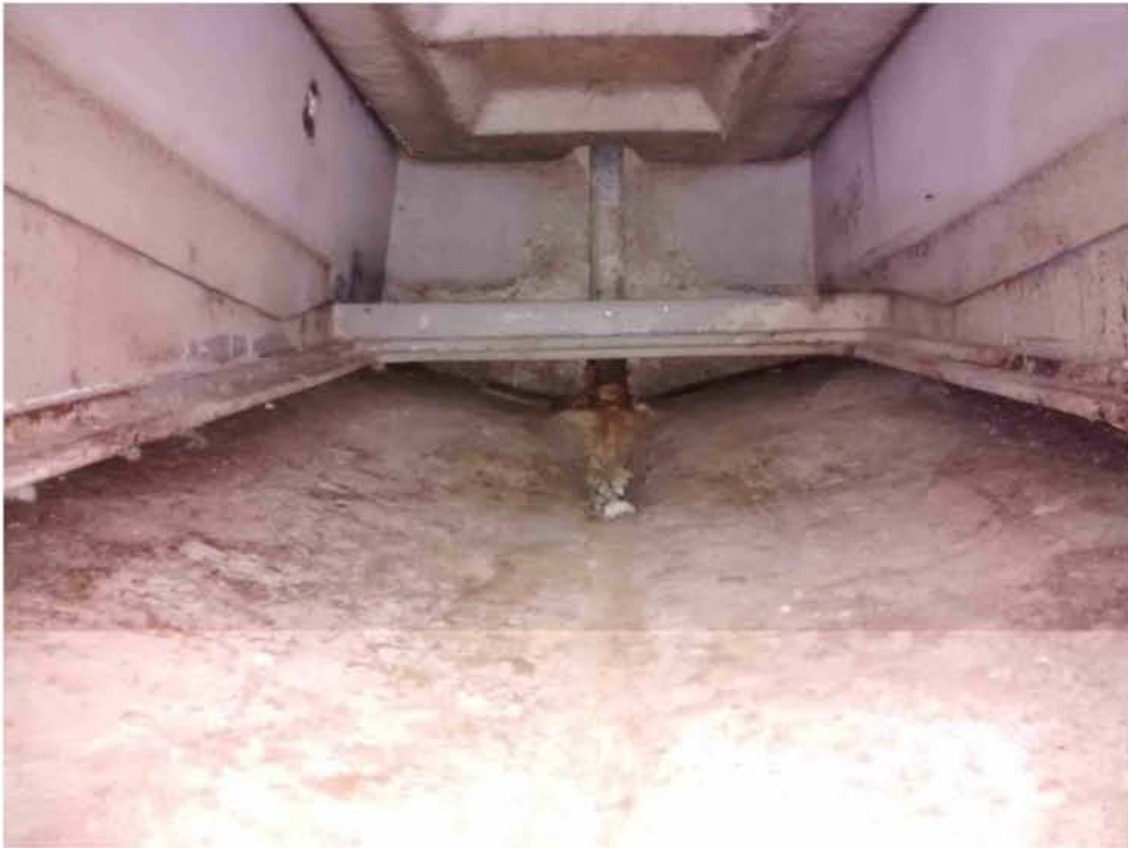
Behold.

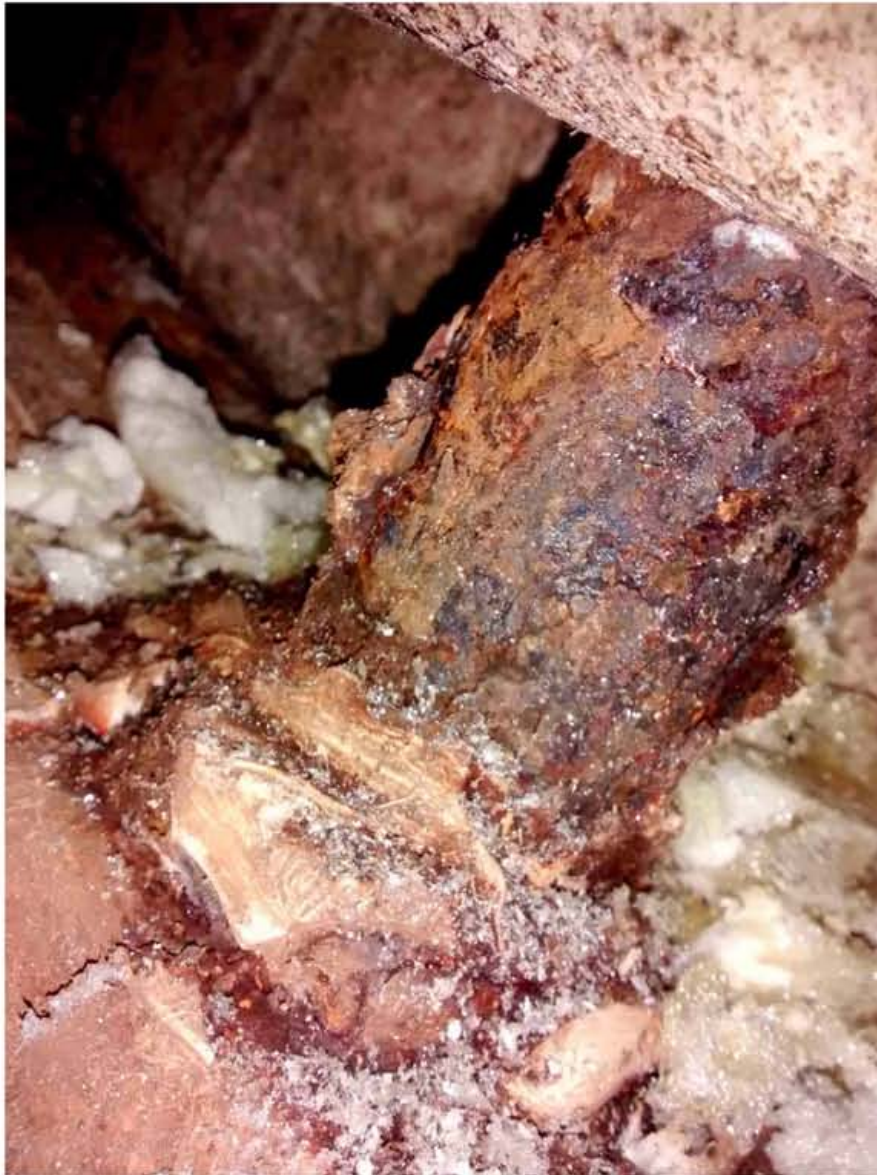
That needs some attention.

It seemed my boat still had the original galvanised scaffolding pole, and considering the state of it I was quite surprised the thing was still floating.

To remove it, I used a combination of angle grinder and hacksaw to cut the tube. Anyone who has done this job knows how cramped and unpleasant it is lying under the cockpit floor, let alone while using an angle grinder. I then used the grinder on the exterior skin fitting with the intention of pushing the remaining section up into the boat from the outside. This took quit a bit of work, and a lot of finesse and care with the grinder. Once I had removed the outside portion and had to apply a lot of torque with a Stilson wrench to twist it free, so much that I actually crushed the ruddertube, but alas, it came free!

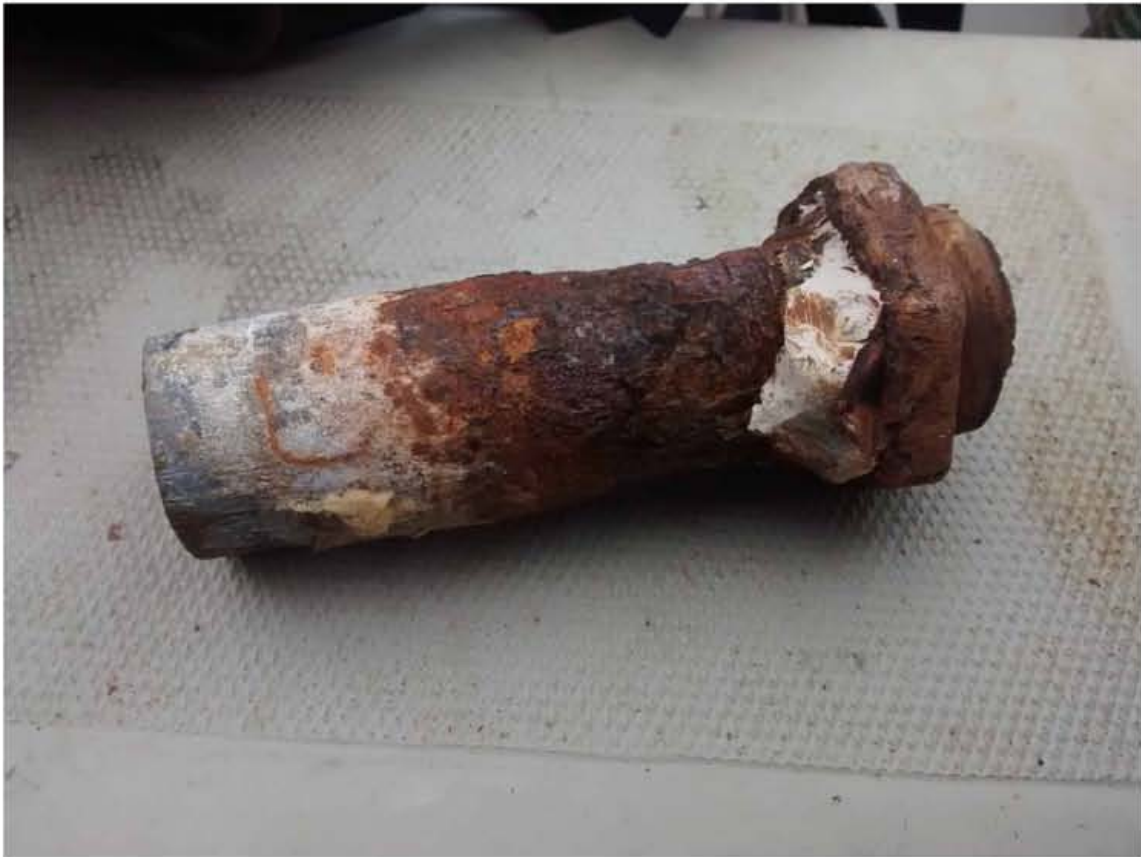
A little piece of history. Or just a poor design feature.

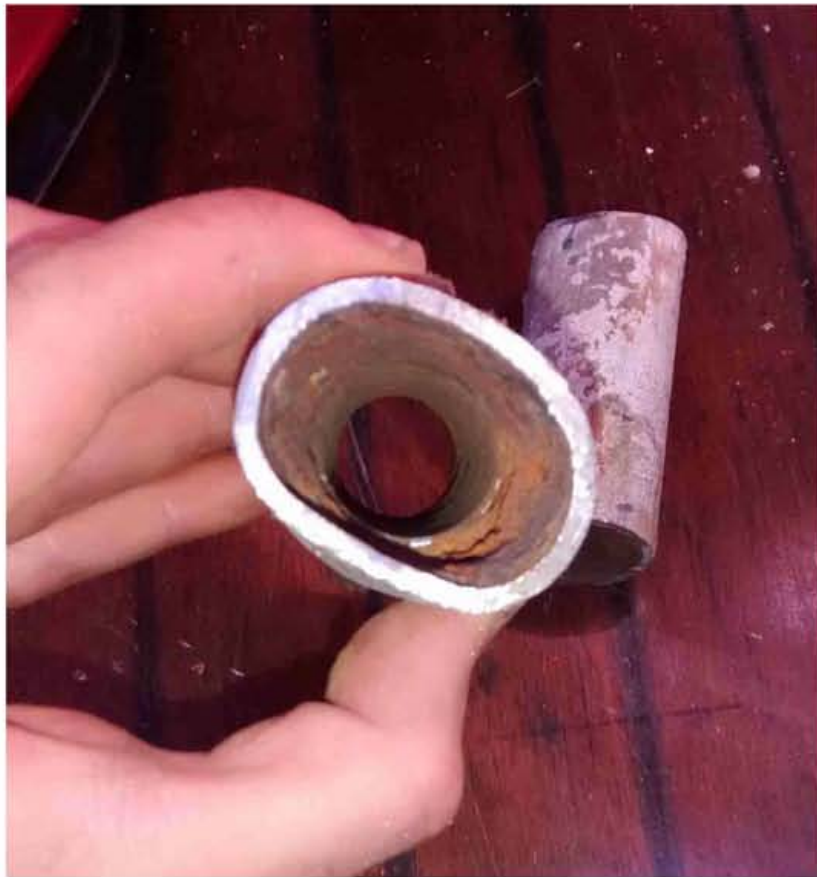
My foe, vanquished.

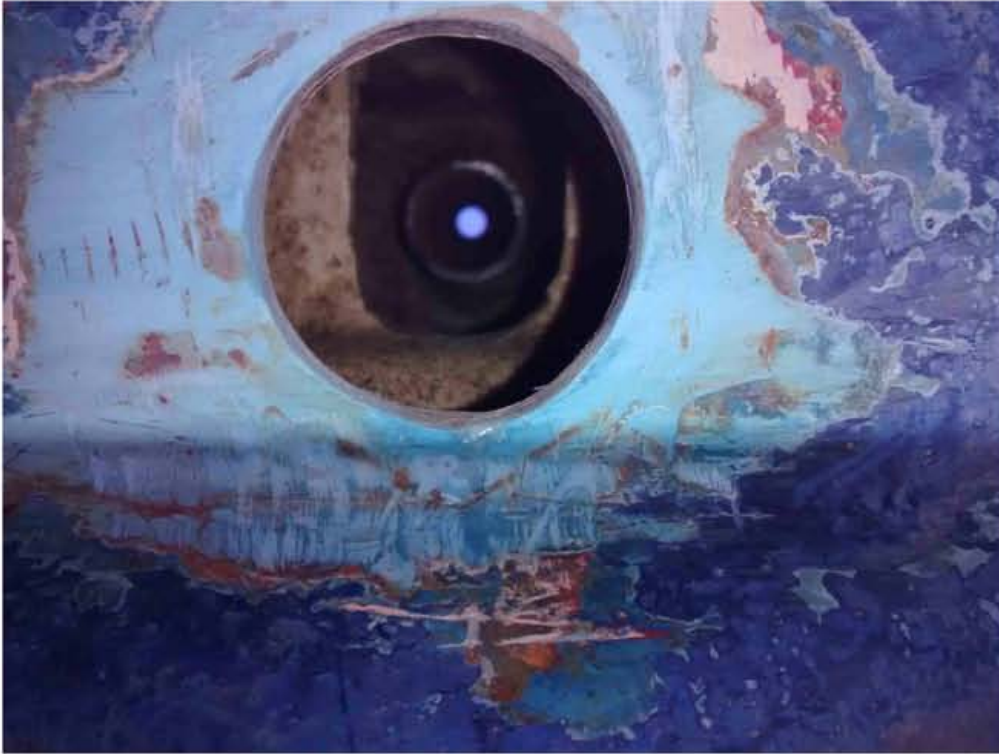
A view from the outside looking up through the remaining ruddertube.

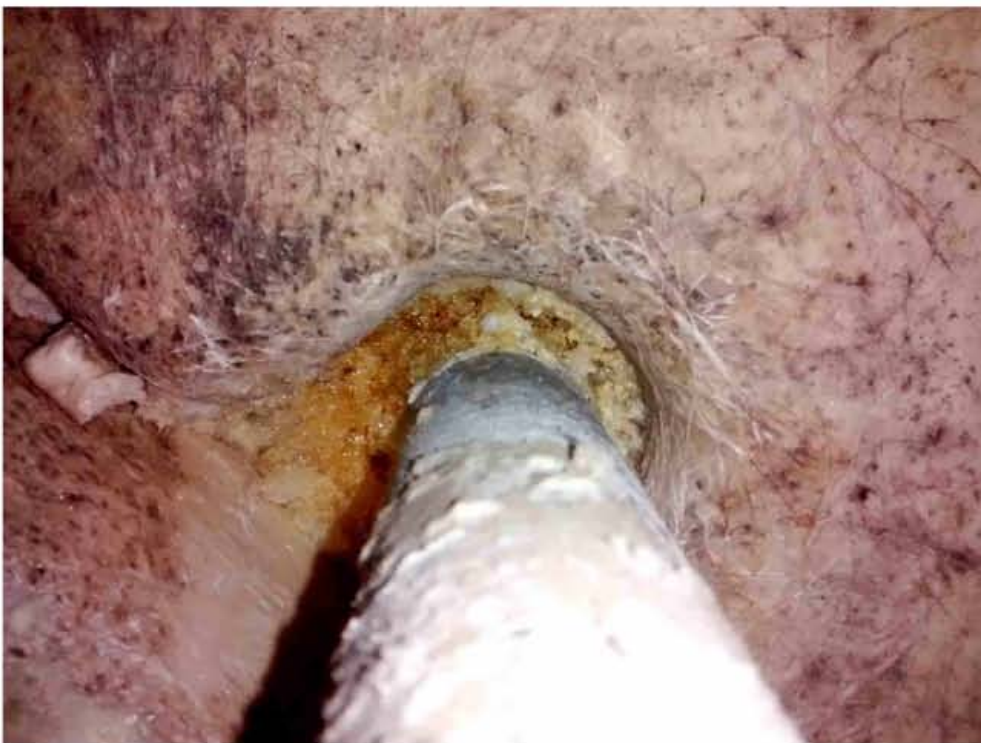
This foe was beyond me.

The foam went to the very top. I cut a small inspection hole in the top of the GRP just below the tiller attachment, and was met with a little patch of indignant yellow foam staring out at me.

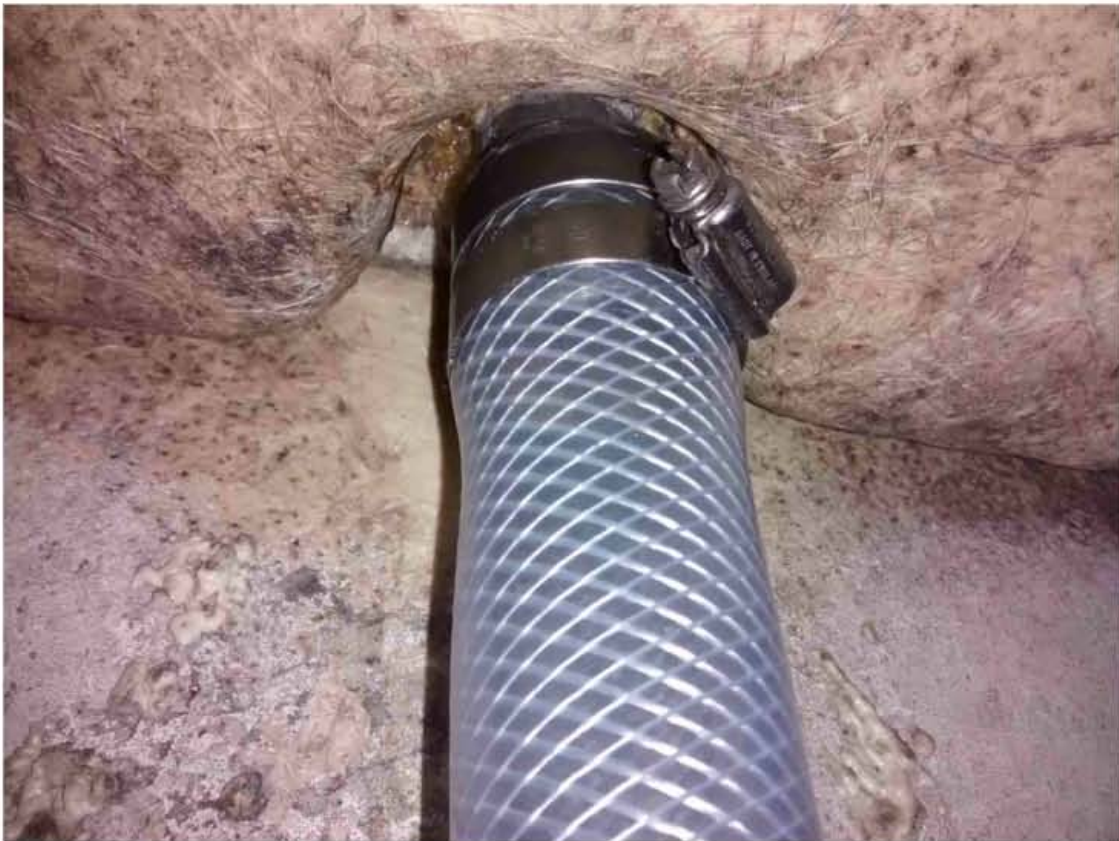
The hose where it connects to the remaining ruddertube.

This whole job was a series of highs and lows, mostly lows and after the eureka moment of finally removing the skin fitting, I eventually realised I could not remove the rest of the tube. I tried mechanical- sawing, chiselling, stabbing, drilling, twisting. I tried chemical- acid, acetone, white spirits. But it was to no avail, the ruddy tube simply would not budge. This essentially ruled out the stainless steel option, at least not without doing some serious GRP surgery, which I had neither the time, inclination, ability or willing budget to do. So I decided to install a 1 1/4" DZR skin fitting with hose-tail and bridge the gap from this to the remaining original ruddertube with some PVC hose. There was a discrepancy however, between the diameter of the hose-tail on the skin fitting and the diameter of the ruddertube. I had to connect these two using a short run of PVC hose. I chose 38mm reinforced PVC hose, which fit perfectly on the skin-fitting, but it was a bit of an effort to get it onto the 42.5mm diameter ruddertube. However with some lanolin grease, some elbow grease and some hot water I managed to get it on, and then clamped it down:

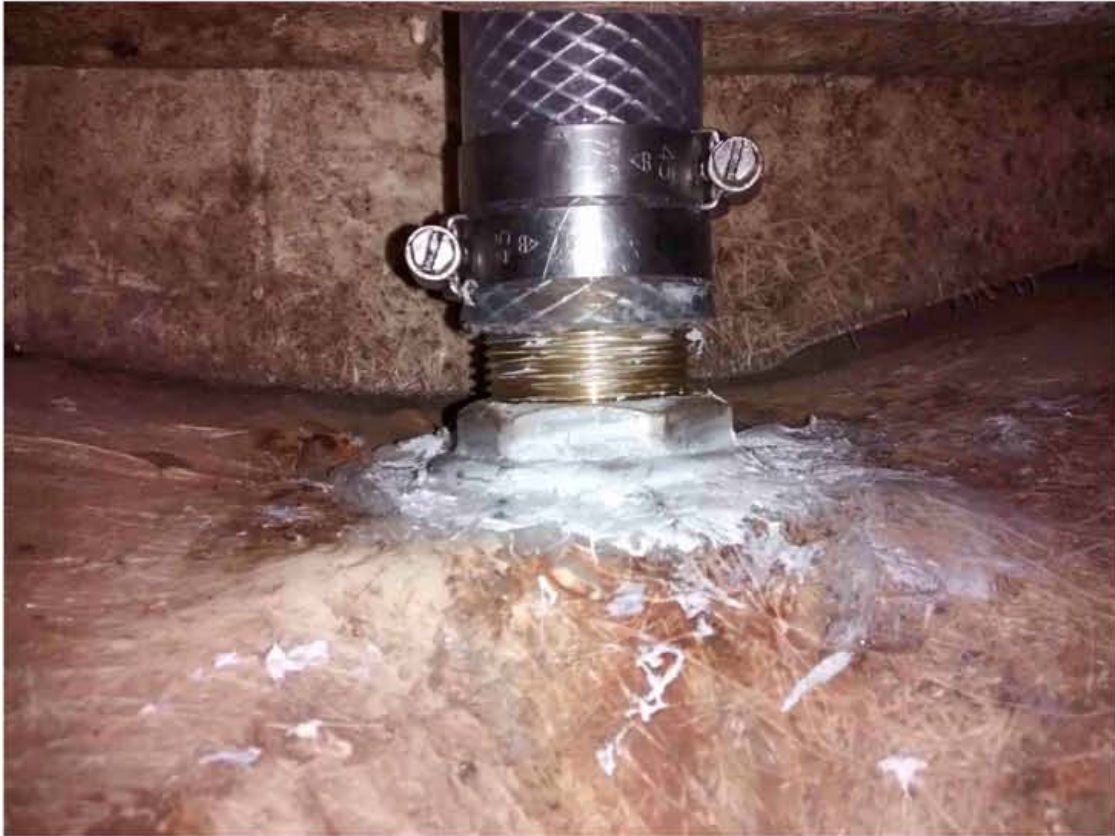
Prioritising function over form.

I must confess I was a little concerned about the structural integrity of this setup, and I kept thinking about the fabulous stainless steel ruddertube setup that some other H22 owners have installed. But I reminded myself that as far as I know, South Coast Marine actually made the later H22 models with a hose and skin fitting rudder tube as standard, so if it is good enough for factory-fitted, then it is good enough for me.

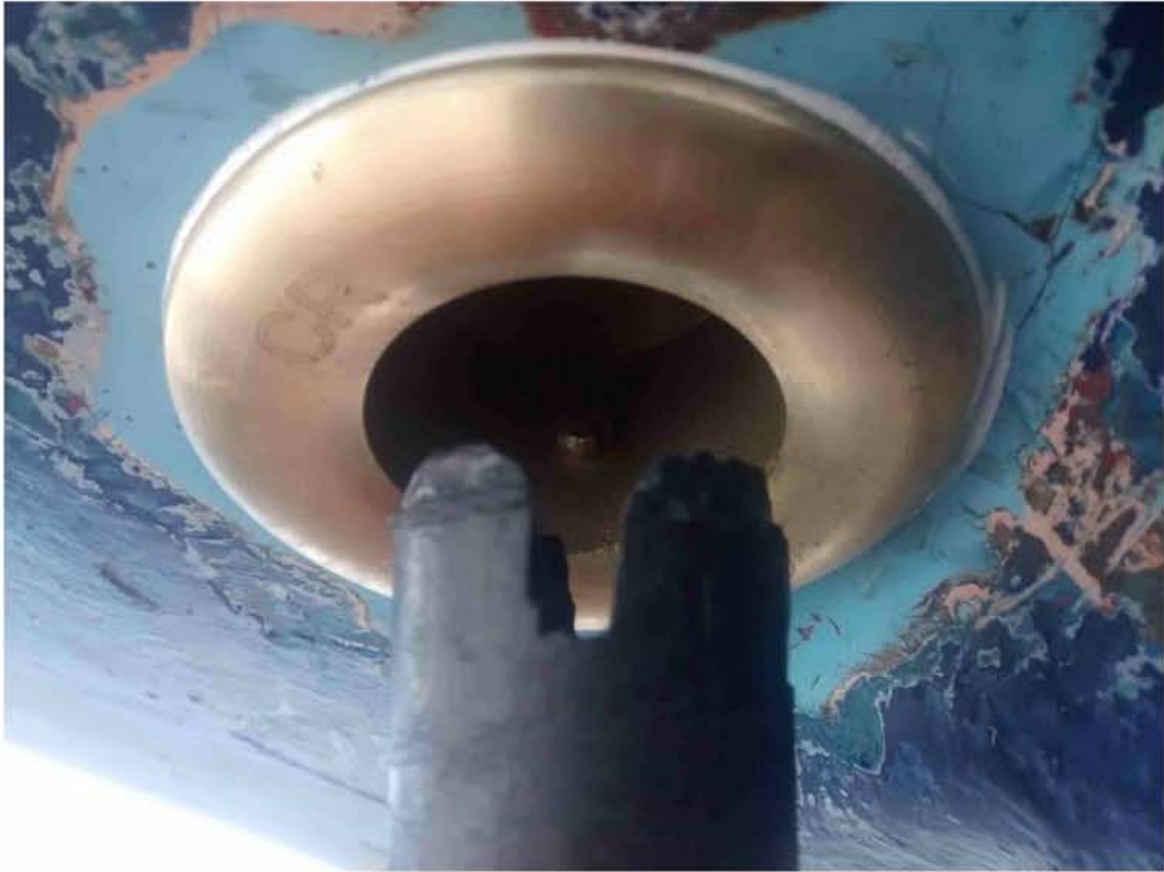
The flimsy bushing.

The only thing left to do was to fit some kind of plain bearing inside the skin fitting to give a snug fit to the rudderstock and reduce play. I tried to be clever and cast a bushing on the rudderstock out of epoxy resin and graphite powder, but it turned out to be too flimsy, so ended up just using a collar chopped of a length of PVC pipe.
